# PUBLIC ROADS

A JOURNAL OF HIGHWAY RESEARCH

Page
Stabilization by Drainage of Muck and Sand Fill . . . . .	57
The Segregation of Water in Concrete Placed in Deep Forms . . . . .	64
Gasoline Taxes, 1931 . . . . .	70

# STABILIZATION BY DRAINAGE OF MUCK AND SAND FILL

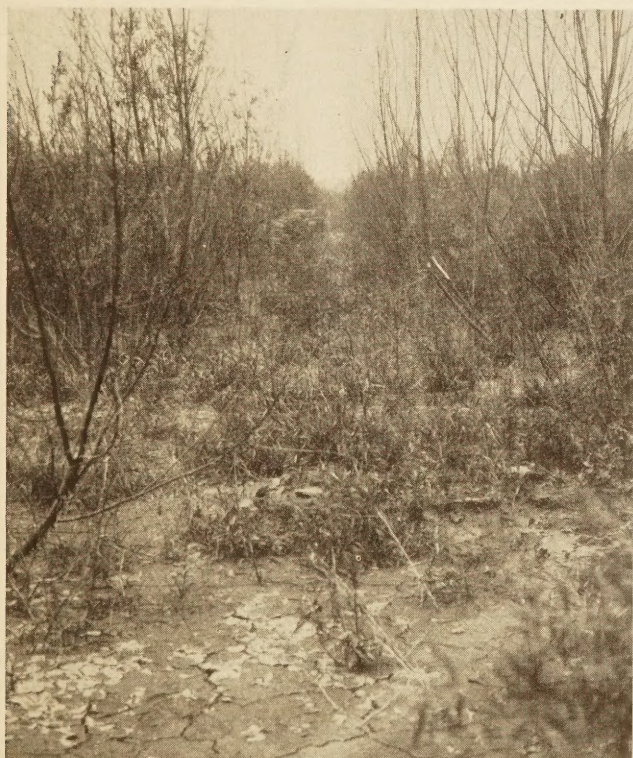
FIGURE 1.—LOOKING NORTH FROM STATION 13+00, ALONG THE CENTER LINE, BEFORE DRAINAGE

At the time it was desired to start grading operations on Columbia Island a section about 300 feet in length between stations 10+00 and 13+00 (see fig. 1) was covered with water and was so unstable that a person attempting to walk along the center line would sink in to his knees.

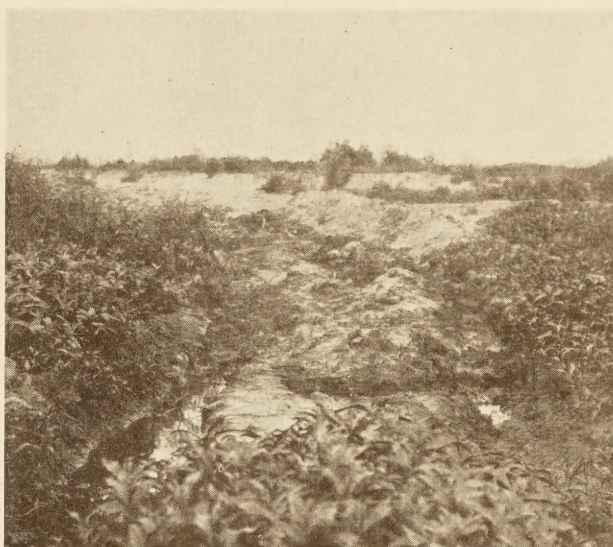
FIGURE 2.—WET AREA AT STATION 20+00. POWER SHOVEL WAS STUCK AT THIS POINT

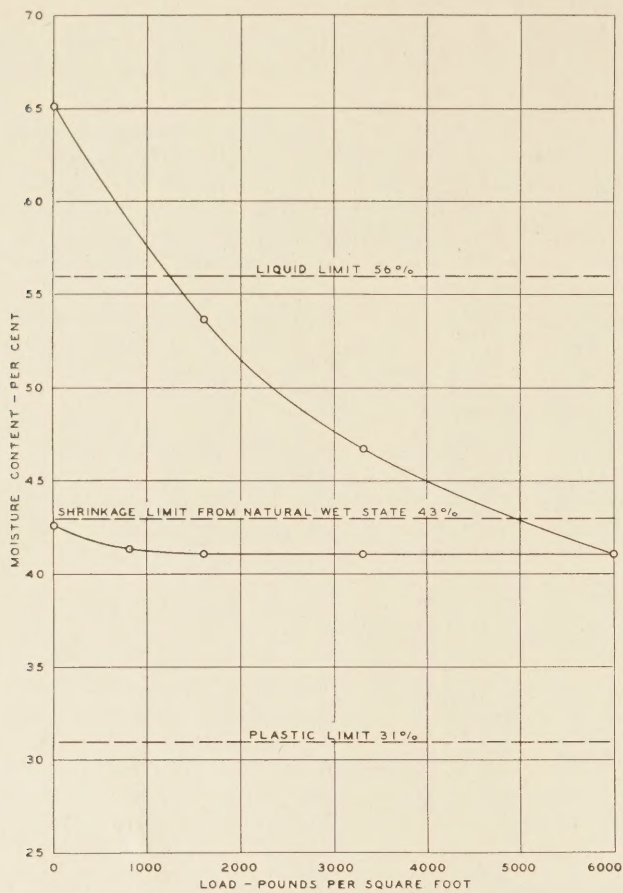
FIGURE 5.—COMPRESSION TEST OF MUCK SOIL IN DISTURBED STATE

Figure 5 gives the results of a compression test which was run on a sample of the muck which had been manipulated. The shrinkage limit value of 43 for the material in the undisturbed state as compared with 34 for disturbed soil (see Table 1) indicates that the support actually furnished by the muck in its natural position might be somewhat higher than is indicated by Figure 5. However, the values shown are of the safe side. Grading operations and the vibrations caused by traffic tend to destroy the natural structure of the material. For this reason the values shown in Figure 5 are believed to be fair. They indicate that under a load of 1,000 pounds per square foot the moisture content will be reduced from 65 per cent to 57 per cent. Under a load of 3,000 pounds per square foot the moisture content will be reduced to 48 per cent; and under 6,000 pounds per square foot the moisture content will be reduced to but 41 per cent or 10 per cent above the stabilization point.

These test data reveal information on two important points. On one hand they show that in order to stabilize a layer of the soil of indefinite thickness by drainage, its moisture content must be reduced below 31 per cent, and furthermore, that it would require a pressure much greater than 6,000 pounds per square foot actually to squeeze the water out. On the other hand, they show that if this muck serves as a base for a new top layer of soil it will support 1,000 pounds per square foot, or an 8-foot thickness of gravel, even with 57 per cent of moisture; and that with a moisture content of 61 per cent it will support a 4-foot layer of ground.

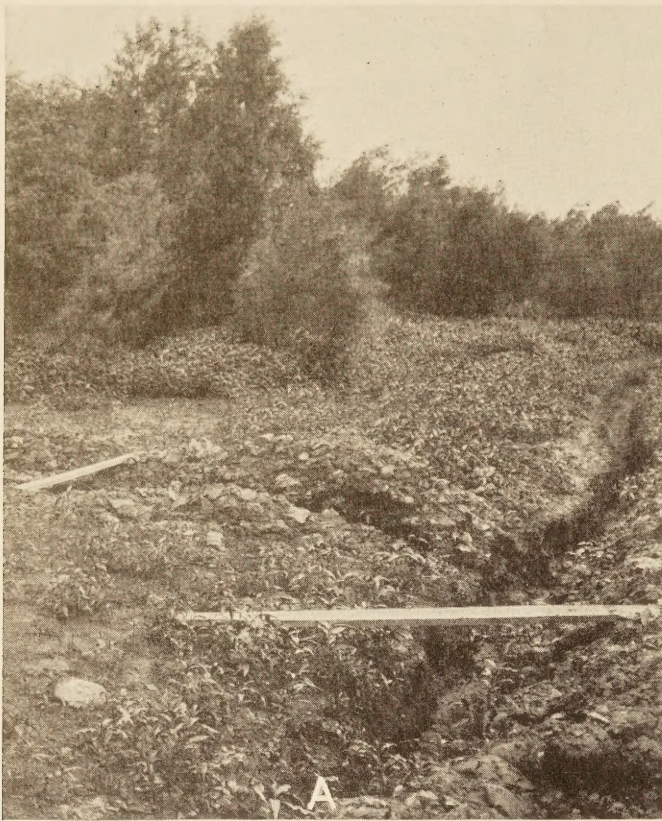
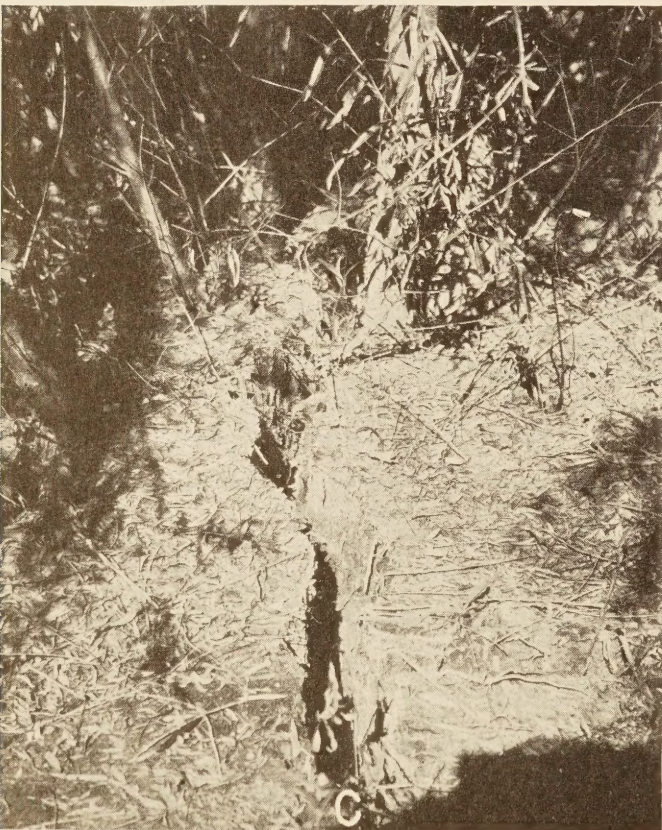
FIGURE 7.—STEPS IN THE DRAINAGE OF COLUMBIA ISLAND

A.—Ditches for removing surface water.

C.—Typical shrinkage crack in wet area after drainage.

D.—Shrinkage cracks in soil after drainage.

through the muck to the sand. The material close to the trench would begin to drain and as it dried out cracks were formed. These cracks, illustrated in Figure 7, C and D, extended back from the ditch and served as water carriers and so the whole area was gradually drained.

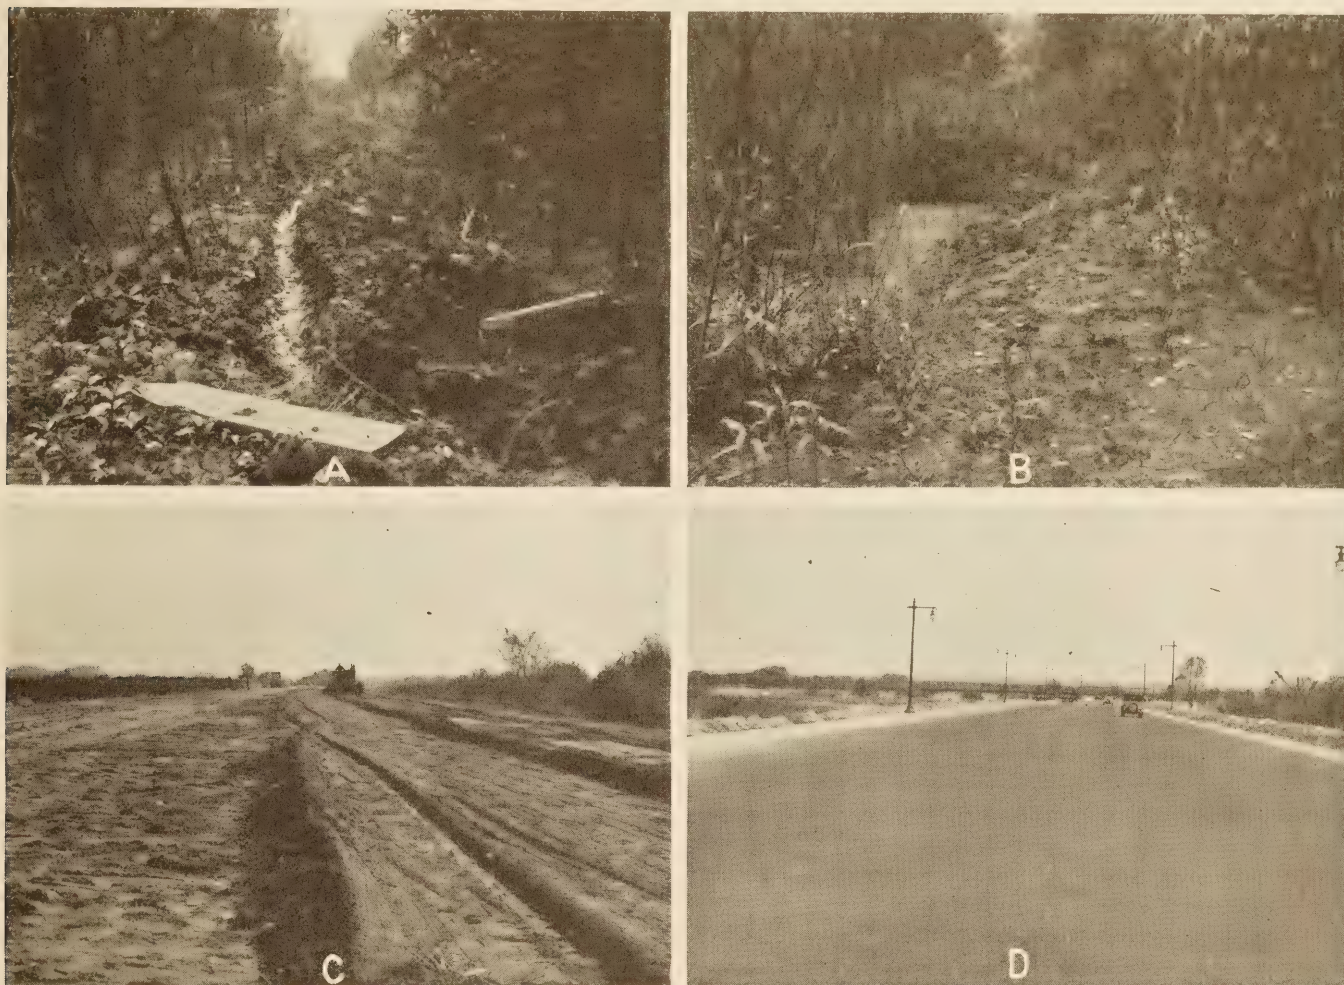
FIGURE 8.—PHOTOGRAPHS TAKEN AT STATION 10+00, AT DIFFERENT STAGES OF THE WORK

- A.—Ditch for removing surface water, looking north from station along center line.  
 B.—Looking north from station after surface water had been removed but before underbrush had been cleared away and underground drainage had been installed.  
 C.—Constructing the fill after drainage, looking south from station.  
 D.—The completed road.

a crust formed. This crust was not very thick, but as it dried out it began to shrink and crack as illustrated in Figure 8, B, indicating that the soil would eventually become more stable if the free water were removed from it.
